Inspection report for the property at  
**123 Main St., Indianapolis, IN 12345**

This report is prepared exclusively for **Sample Customer**  
Inspected On: **08-12-2026**

Dana Renay, Indiana State License  
#HI02600037

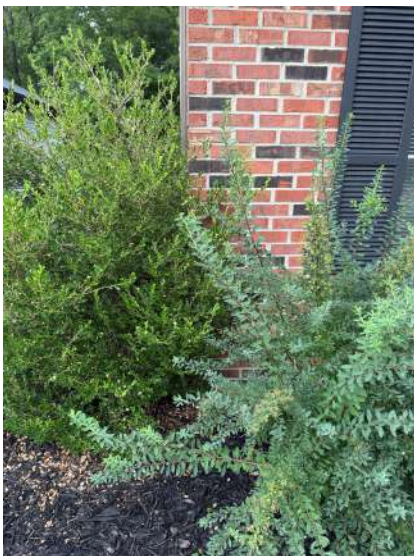
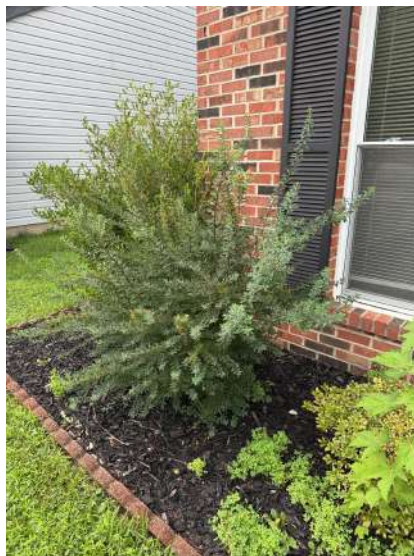
Bushes are directly against the house. All vegetation, including smaller landscaping such as grasses, flowers, and shrubs should be kept 1 foot off the house to eliminate contact which could trap moisture against the building.

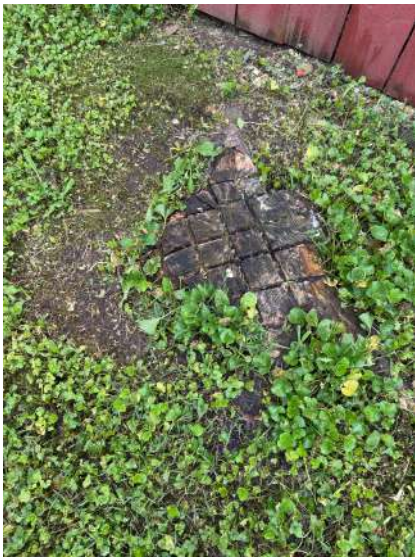
✂️ (2.3.2) Minor Defect: Rotting stumps are common areas that can attract wood destroying insects like termites. I recommend having the stumps completely removed or treated to avoid any infestation that could lead insects to the house.

*Rotting stump by backyard fence  
left side*

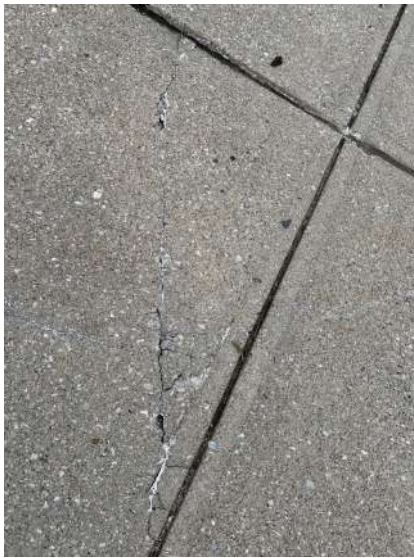
*Cracked and sunken piece poured concrete seems to have been repaired previously*

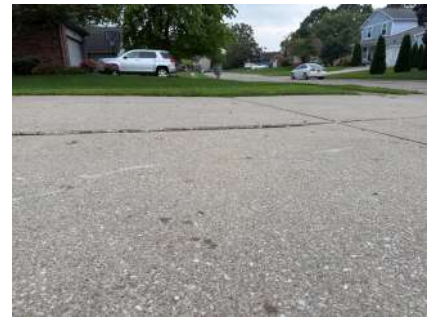
*Sunken in the middle*

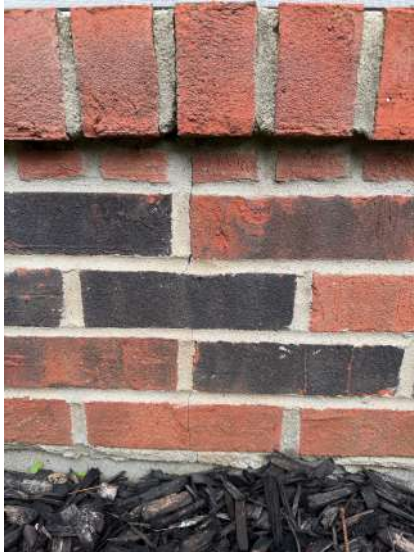
*Crack And Brick under first story front window*

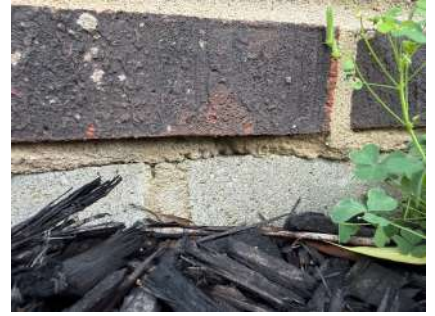
*Under first floor window front of house*

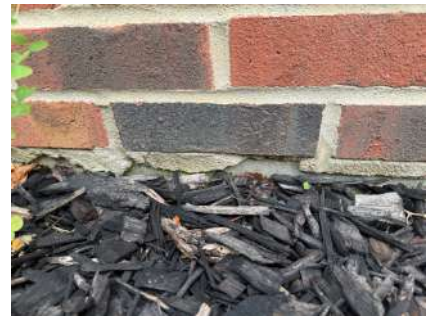
*Cracks in mortar right side front*

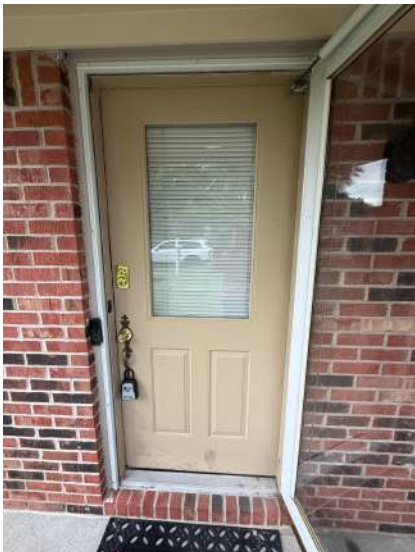
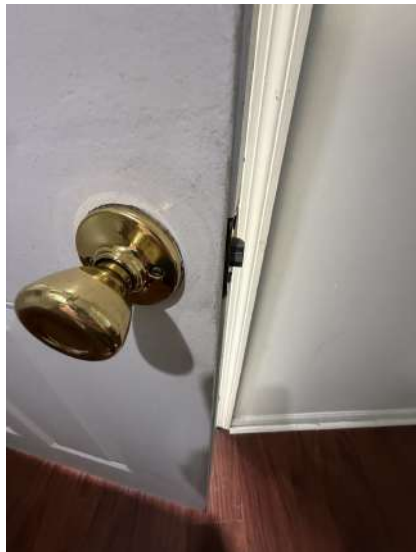
✂ (3.2.2) **Minor Defect:** The front door was incredibly difficult to open. The threshold is uneven which causes the door to stick. Also, the front door knob is only partially functional.

The storm door does not fully close, and the area where the door closer attaches to the frame is damaged. This can cause a serious hazard if the closer pulls away from the frame by allowing the storm door to slam.

*Front door knob*

I recommend having a contractor replace the knob and level the threshold. They can also repair the damaged wood on the frame

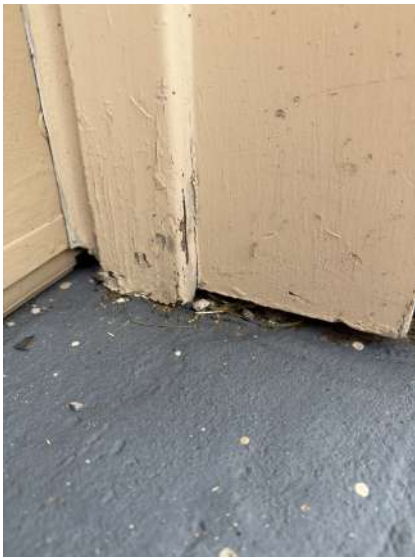
*Right side, garage door, beginning to rot recommend raising the trim quote. Stop above the concrete to prevent water from entering.*

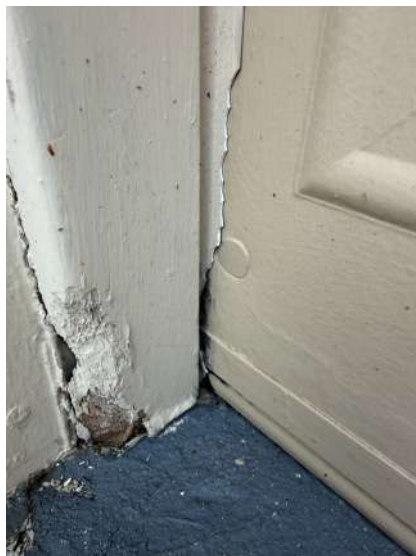
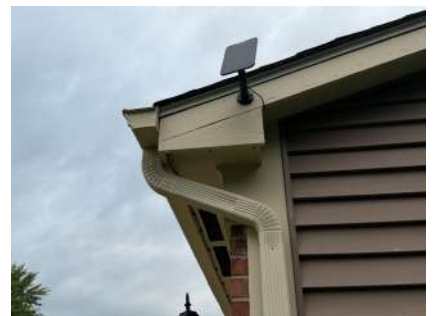
**🔧 House Exterior - Siding and Trim:** The trim along the roofline at the back of the house was damaged. This could be caused by woodpeckers or wood destroying insects (or both).

**Defective:** The trim along the roofline at the back of the house was damaged. This could be caused by woodpeckers or wood destroying insects (or both).

I recommend having the trim replaced to prevent water from getting in or further damage.

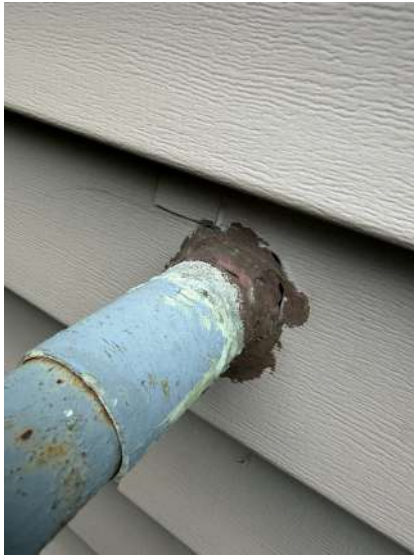
The pipe going into the house wasn't adequately sealed. I recommend having a contractor seal the penetration.

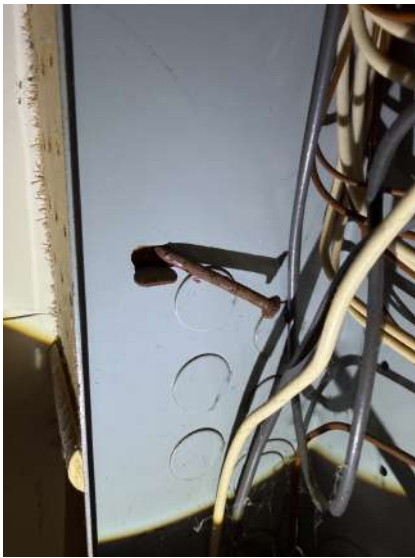
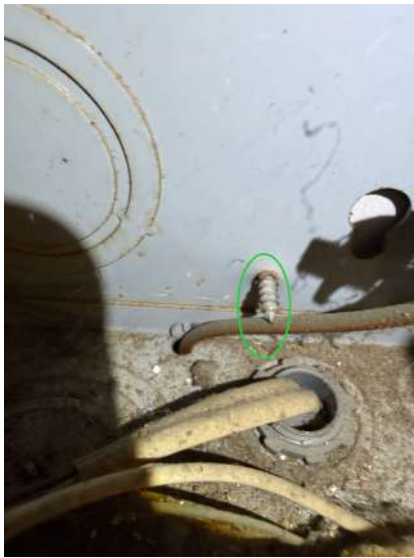
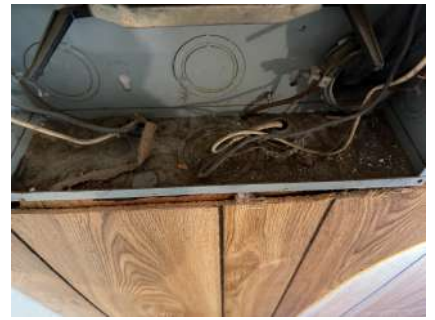
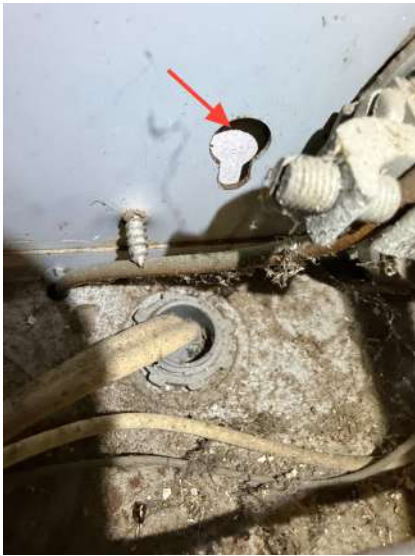
Exterior fasteners / nails were noted penetrating the electric panel. A non-standard, rusted nail was observed inside the main electrical panel box, positioned in close proximity to sheathed branch circuit conductors.

Fasteners, especially those with sharp points, can scrape or puncture wire insulation over time due to thermal expansion, vibrations, or panel cover pressure. The nail was rusted which may indicate moisture exposure inside or around the enclosure, which can degrade electrical components.

I recommend additional inspection of this panel by a licensed electrician to make sure this panel will perform safely and as intended.

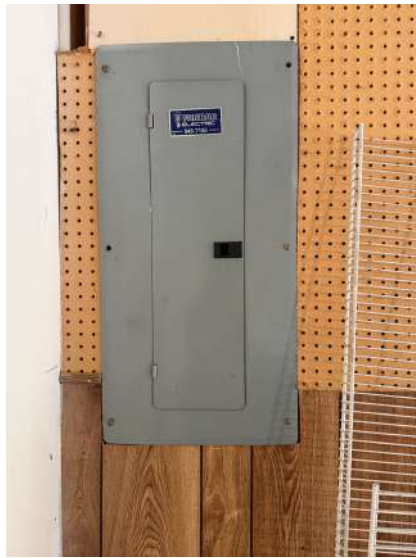
There was debris on the bottom of the panel. This is a fire hazard if there is ever a spark. This should be cleaned out.

The main panel is missing proper screws to secure the dead front cover. Install missing screws as needed for improved safety and please note that screws with sharp ends are not recommended.

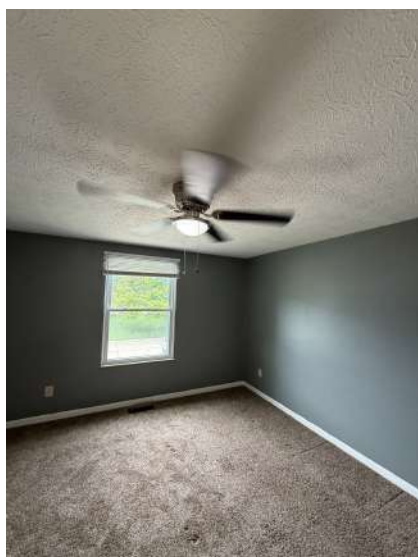
These ceiling fans were poorly mounted and loose. This could pose a safety hazard. I do not inspect the ceiling fan mounting but It is important the ceiling fans get well-mounted to the ceiling with proper fan fixture boxes. I recommend have these appliance further evaluated and repaired as recommended by a qualified electrical contractor to ensure safe and reliable performance.

*Gray bedroom fan was slightly noisy*

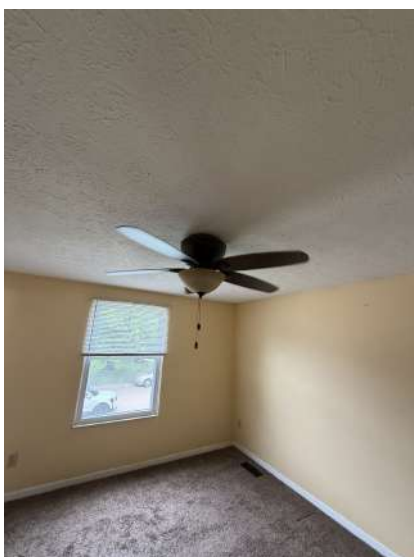
*Yellow room fan was loose*

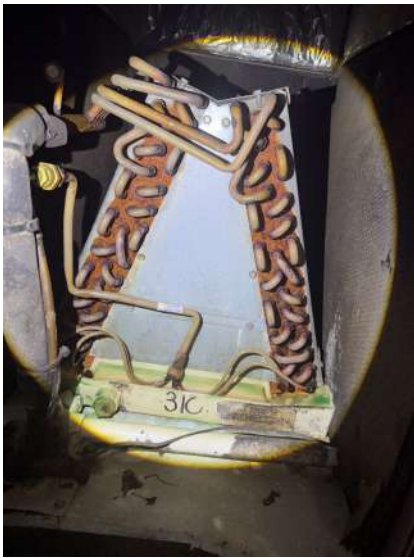
*Evaporator coil*

I observed heavy surface corrosion / rust on the evaporator coil and stagnant water in the primary condensate collection pan. This could imply a malfunctioning or partially restricted drainage system.

I recommend having a licensed HVAC contractor evaluate and repair.

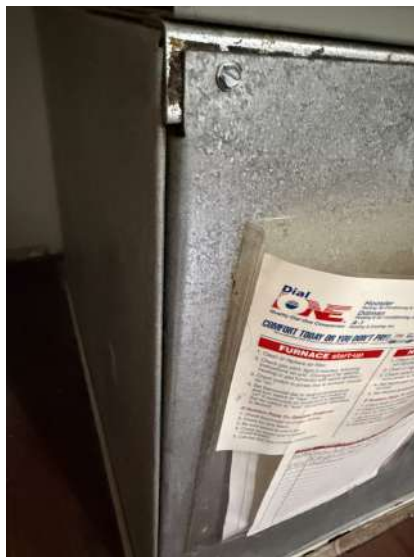
*Air leaking out*

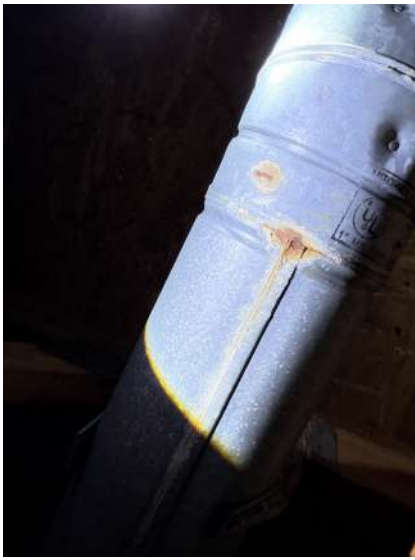
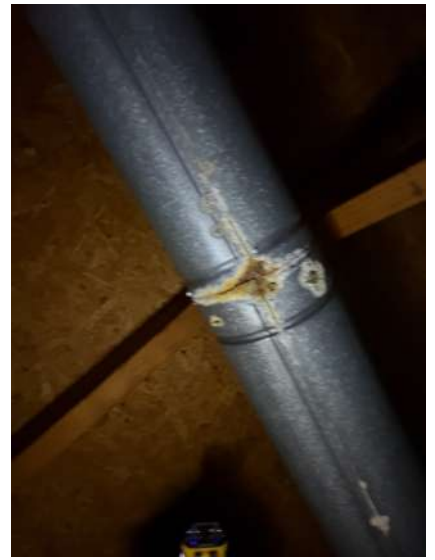
**Defective:** The ducts in the attic over the garage have holes due to corrosion. I recommend having an HVAC technician evaluate and replace.

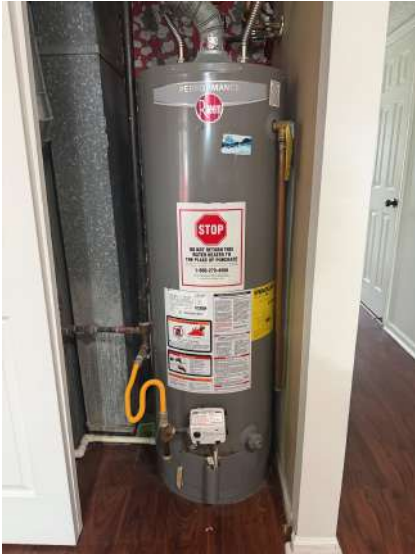
Additionally, there is no pan underneath the water heater, so if the relief valve opens, there is no where for the hot water to go other than onto the floor.

I recommend a licensed plumber evaluate and repair as needed.

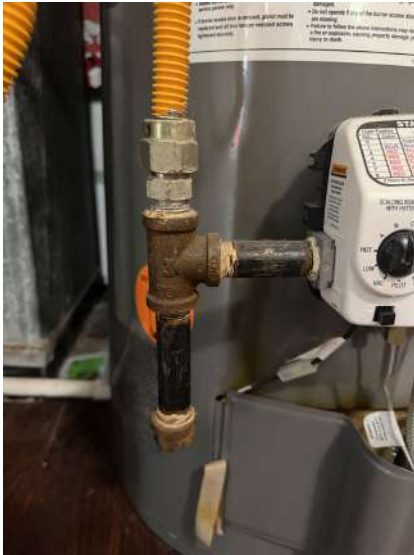
## ✂️ (10.1.2) Minor Defect: Corroded connectors

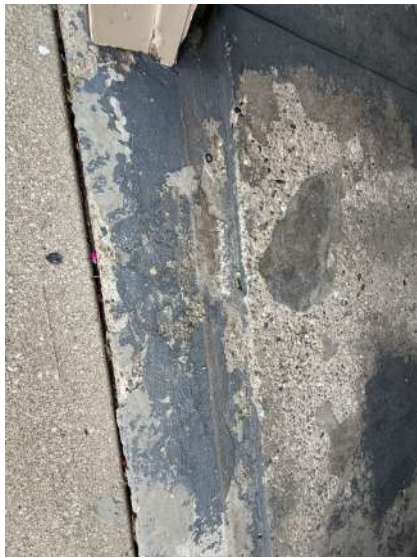
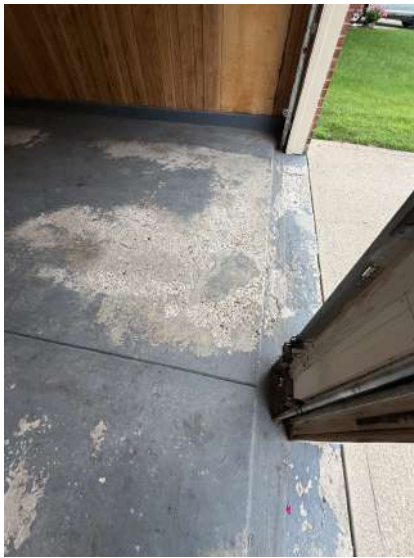
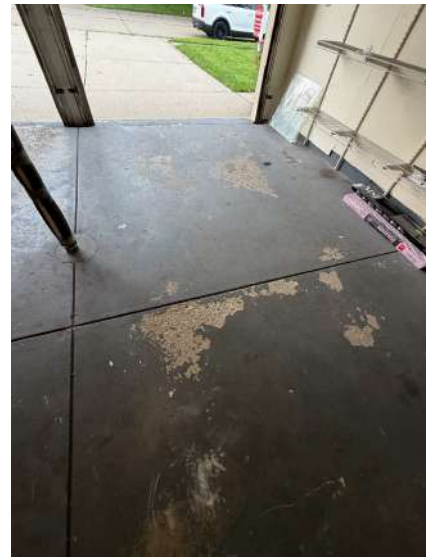
**11.3.1 Garage - Garage Floor:** There was significant spalling across the garage floor. Without repair, this can continue to damage the floor to the point it will need to be replaced.

🚧 (11.3.1) Defective: There was significant spalling across the garage floor. Without repair, this can continue to damage the floor to the point it will need to be replace.

I recommend having a concrete professional evaluate and possibly repair these areas.

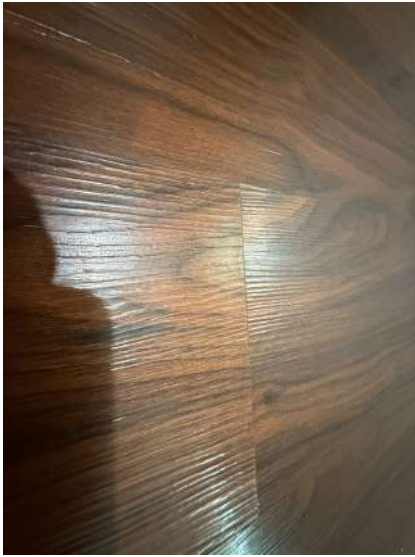
The top/bottom of some of the boards was beginning to peak. It is important to remember to keep the floors dry as this material can quickly warp.

*Very slight lifting at edges of flooring*

I recommend contacting general contractor to repair or update this finish flooring as needed.

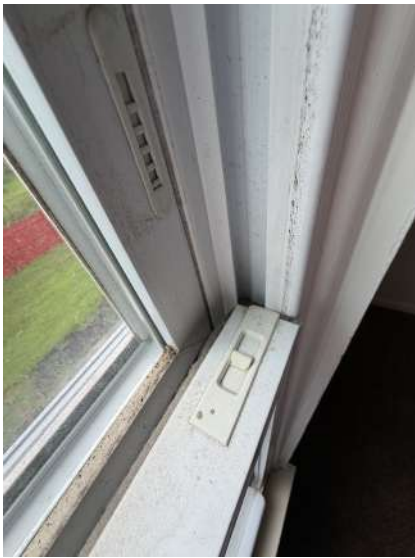
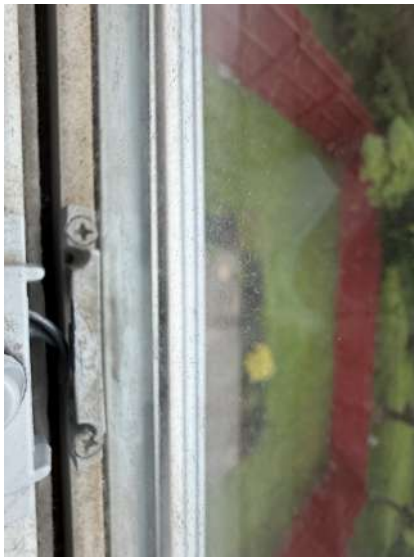
**Defective:** The window in the cream room was difficult to open and easily came off of the track.

*Cream room window does not lock misaligned coming off of track*

I recommend having a window specialist evaluate as needed.

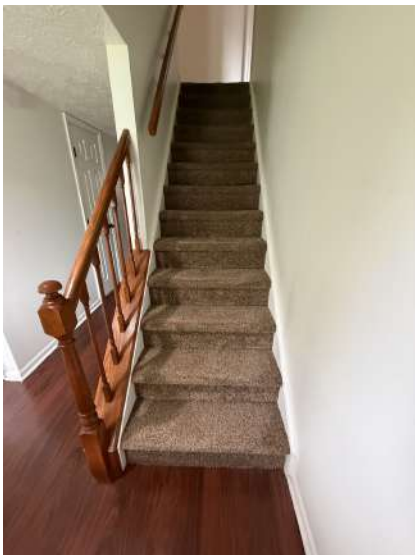
✂ (12.7.1) **Minor Defect:** The railing was loose

*Loose banister*

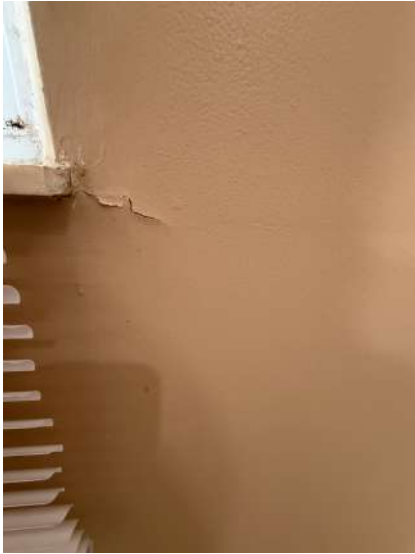
✂ (12.8.1) **Minor Defect:** There were some cracks on the corner of some windows.

*Crack on the right of master bathroom window. Most likely drywall tape.*

I recommend having a contractor repair as needed.

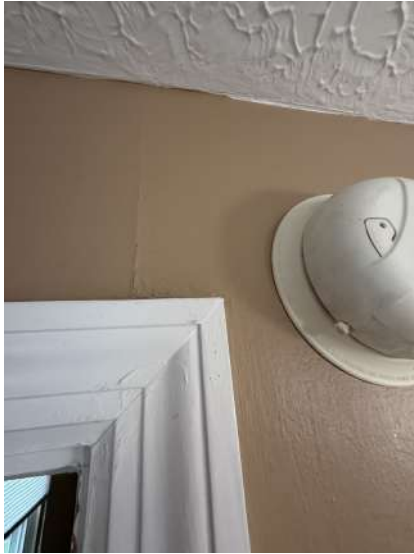
*Vertical crack on inside of master bathroom*

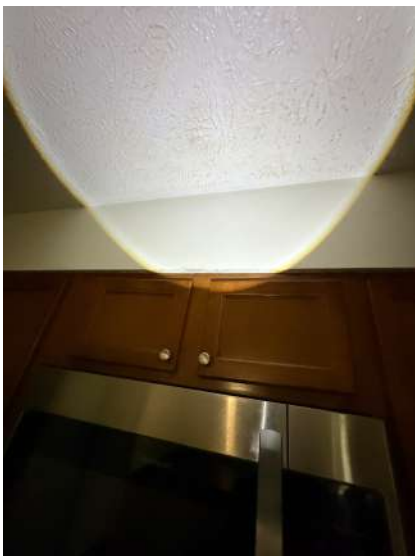
*Kitchen ceiling over stove has discolored because of lack of ventilation*

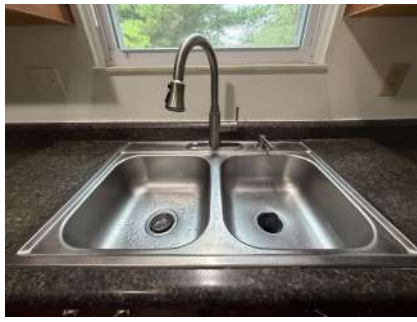
**Defective:** The sink surround was loose on the back. It should be secured.

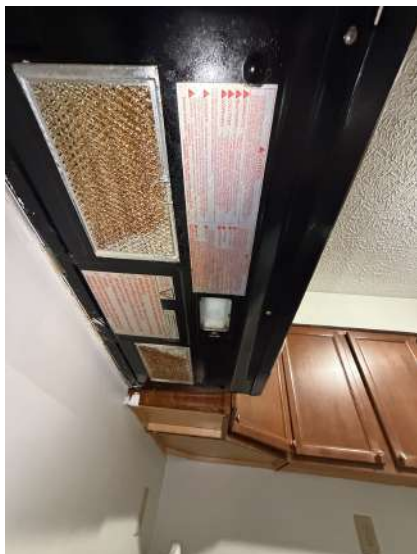
✦ **Additional information:** I was unable to know if the fan underneath the microwave was pulling appropriately, but it was dirty.

Cleaning is recommended for improved reliability and safety as you do not want to allow for extensive grease build-up.

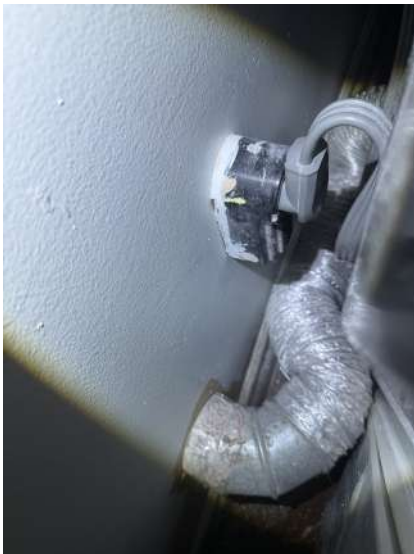
- ✂ (14.4.1) **Minor Defect:** There were several minor issues, including:
- The duct termination on the exterior is covered with a screen (that is dirty).
  - The corrugated dryer duct is too long and serpentine. This can act as a lint trap and cause the dryer to vent poorly. This can even become a fire hazard. I recommend using metal flex duct to connect and clean out the dryer vent.

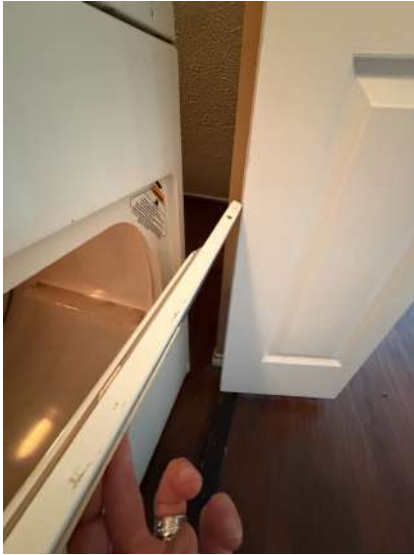
✂️ **(14.4.2) Minor Defect:** The dryer door hits the bi-fold door restricting it from opening completely.

*The dryer door hit the bifold door, restricting it from opening*

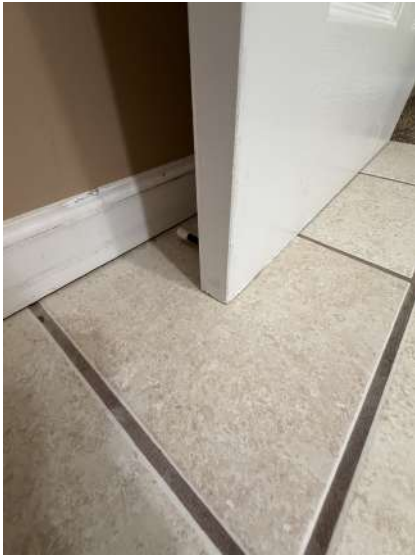
✂ (16.2.1) **Minor Defect:** The door to the bathroom sticks on the tile close to the wall.

*Master bedroom door sticks to tile when open*

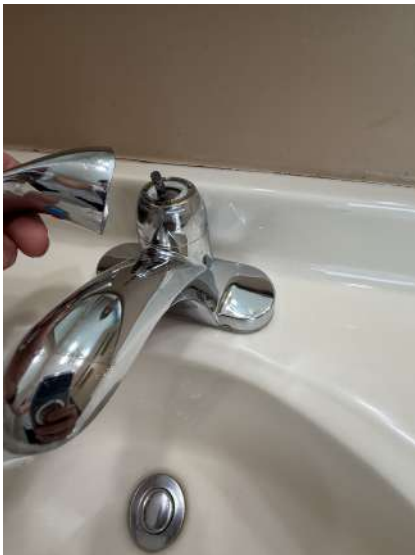
✂ (16.3.1) **Minor Defect:** Loose / broken faucet handle. I recommend replacement.

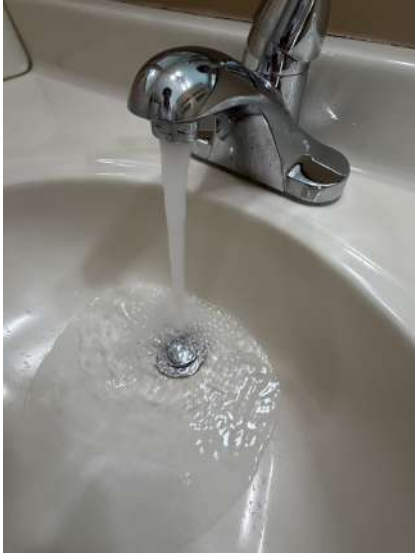
*Left sink drain bubble*

I recommend having a licensed plumber evaluate and repair as deemed necessary.

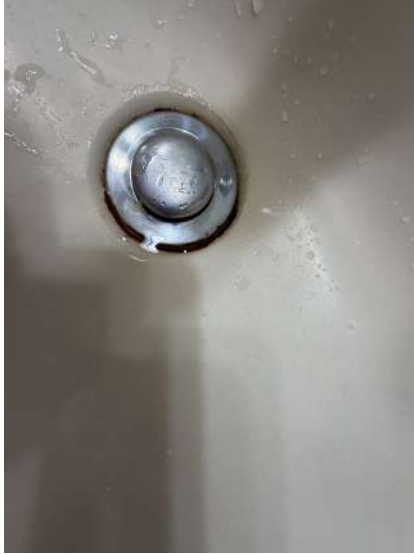
*Corroded drain right side*

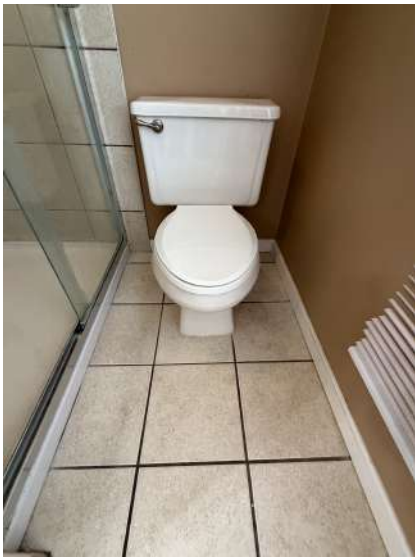
- The toilet is not securely mounted onto the floor
- The toilet doesn't flush
- The seat is loose

*Toilet is loose and does not flush*

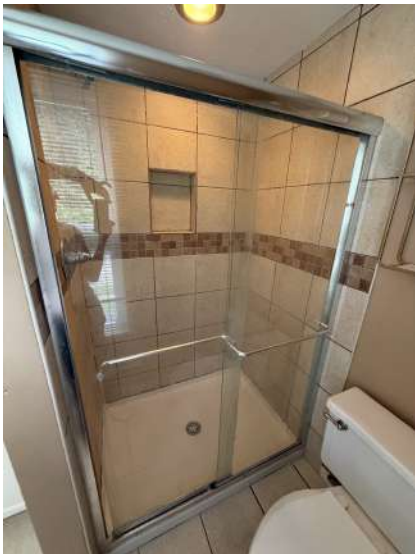
*Bacterial growth behind caulk*

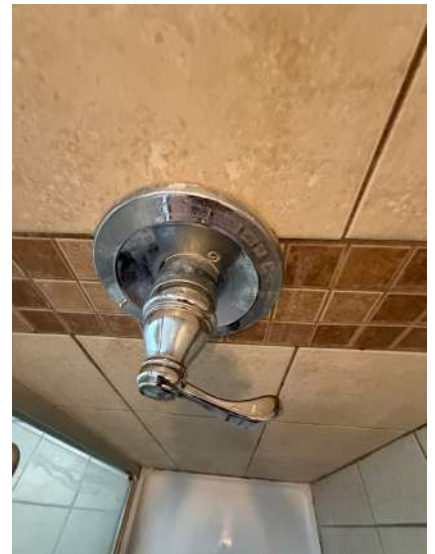
*Feel around metal piece  
connected wall  
Handle is loose*

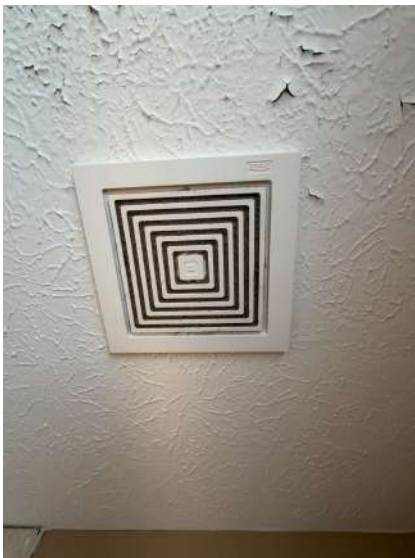
The bath fan is dirty. Cleaning is recommended to ensure reliable performance.

*drywall compound is peeling  
around that fan  
That fan is very dirty and not  
pulling Erin*

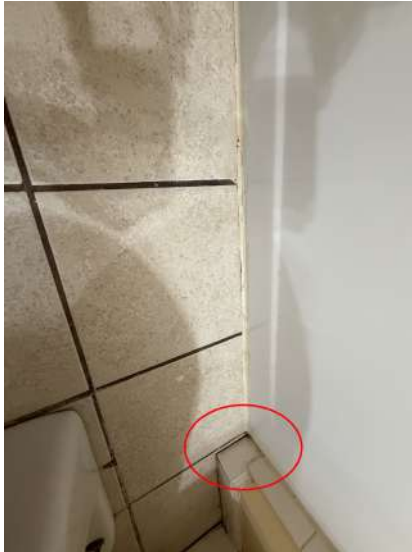
*Caulk between floor and tub  
cracked trim next to tub*

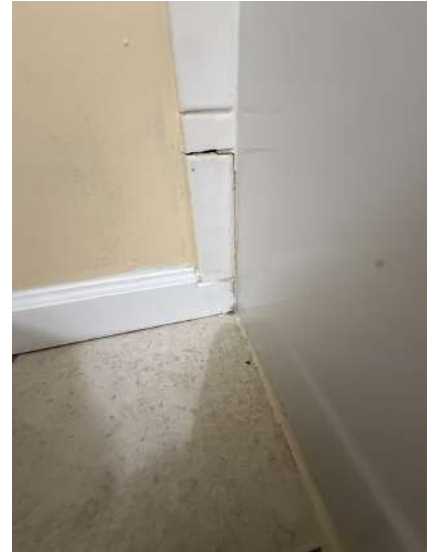
*Tile needs to be secured*

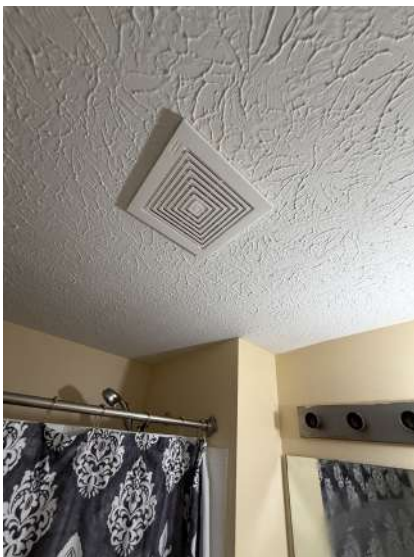
The bath fan appears to be working poorly and may no longer provide adequate air exchanges to keep this bathroom dry. I recommend cleaning or replacing the fan.

*Fan in Hall bathroom may not be pulling*

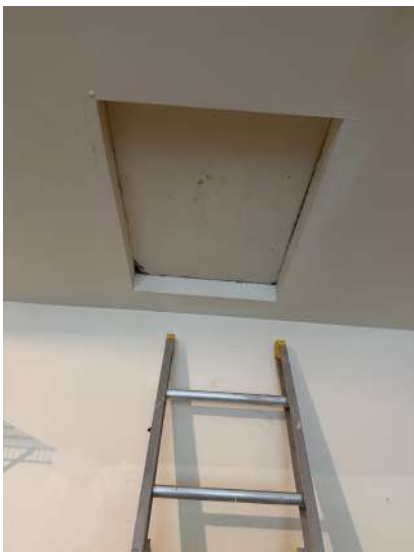
🔧 (19.1.1) **Minor Defect:** There is a whole in the attic access door.

*Garage door access*

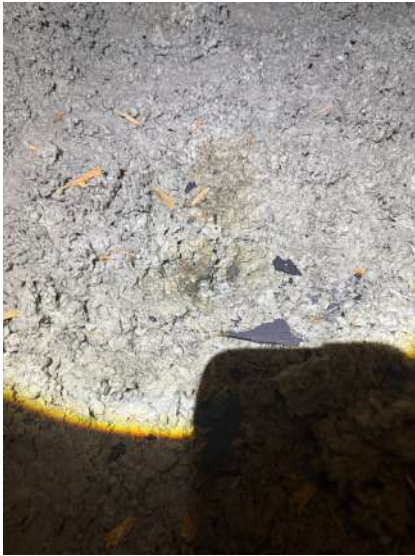
✂ (19.3.1) **Minor Defect:** There is wet insulation below the air duct penetration. I recommend replacing it to avoid any bacterial growth.

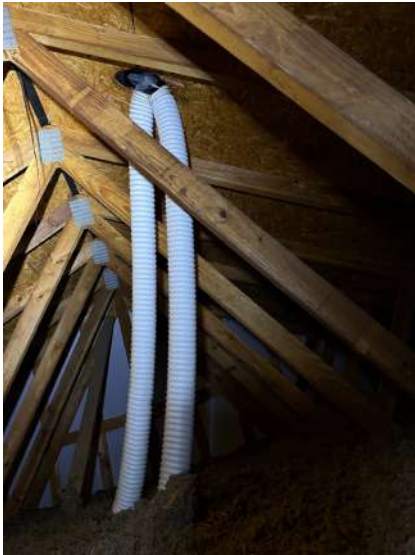
🔧 **(20.4.1) Minor Defect:** I was not able to confirm that these vents were active or not. I recommend having an HVAC technician evaluate and ensure that if they are active, they properly vent outside.

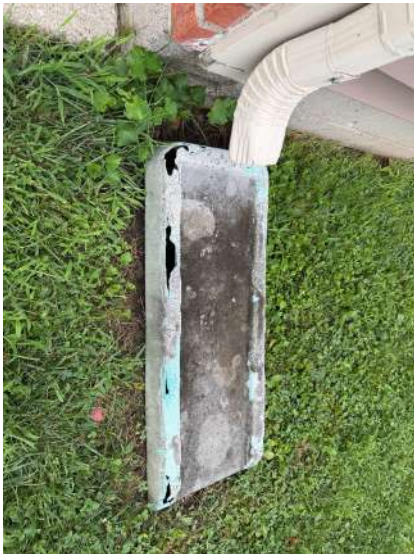
**Additional information:** I recommend replacing the downspout extensions that have holes or are damaged to ensure water flows away from the house.

*Front right side downspout  
replace extension*
