Inspection report for the property at  
**123 Main St., Indianapolis, IN 12345**

This report is prepared exclusively for **Sample Customer**  
Inspected On: **08-12-2026**

Dana Renay, Indiana State License  
#HI02600037

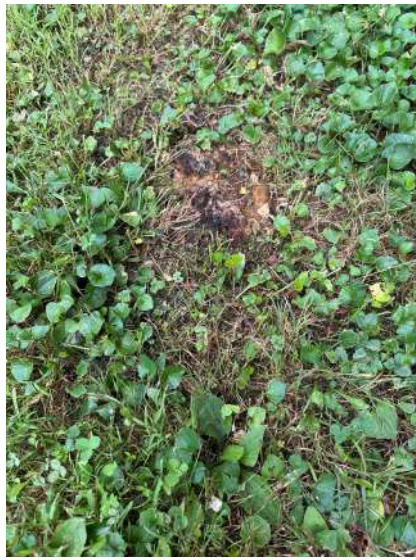
*Rotting stump by backyard fence  
left side*

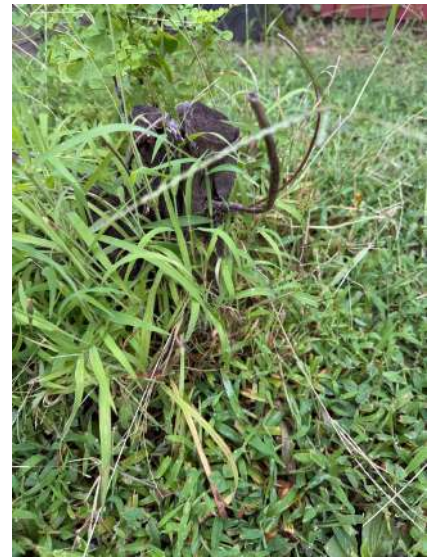
*Rotting stump left side of house*

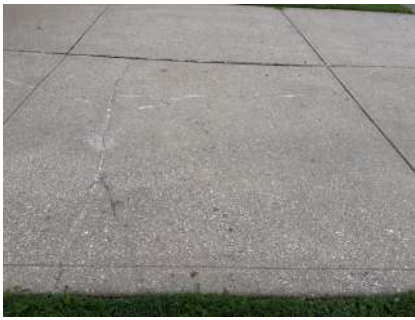
One of the slabs on the driveway had a large crack that appears to have been previously repaired; the repair was failing. The corner of the same slab was also cracked with loose concrete around it.

*Cracked and sunken piece poured concrete seems to have been repaired previously*

I recommend having a concrete professional evaluate this area and possibly replace this slab and determine what should be done with the other damaged areas.

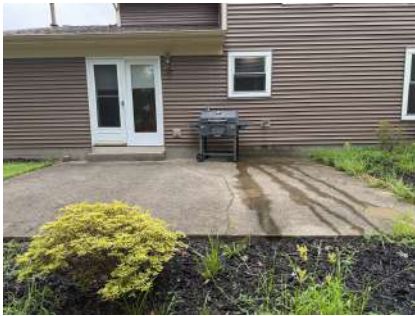
*Back porch*

There were similar large cracks on the back patio.

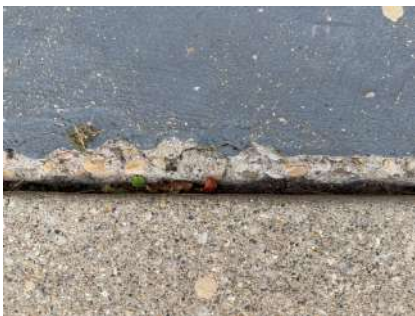
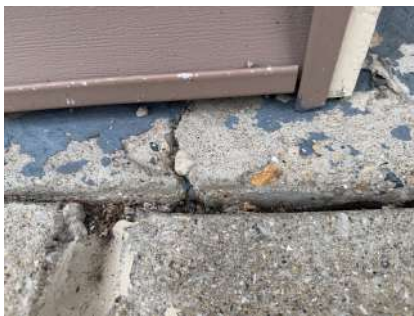
**⚠ (2.4.2) Major Defect:** Where the driveway meets the garage apron there was significant spalling and cracking. The apron was higher than the driveway, which could indicate that the driveway had sank over time.

There was a large gap between the driveway and apron, which allows water to enter underneath both the garage and driveway slabs. This was a trip hazard.

I recommend having a concrete professional evaluate and repair.

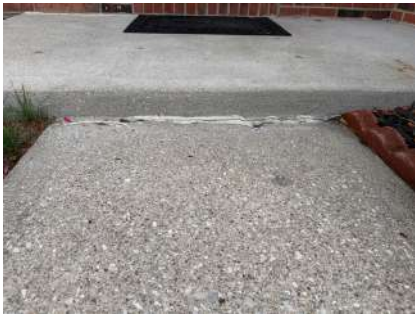
**Defective:** There was a gap between the front walkway and the front stoop that had been previously repaired. These repairs had failed, allowing water to enter. This can cause damage to both areas when water gets between them.

I recommend having a concrete professional evaluate and repair.

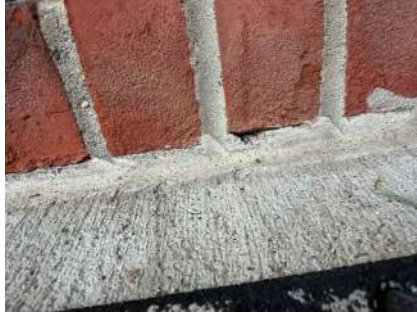
*Under front door*

- Bricks around the house had cracked and/or missing mortar.
- There were areas where the flatwork meets the brick was not sealed
- The front and back door step were not sealed at the edges or bottom

I recommend having a masonry professional evaluate and repair

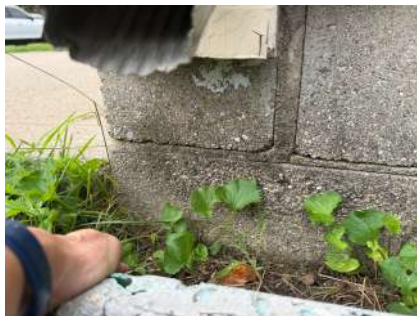
*Cracks in mortar right side front*

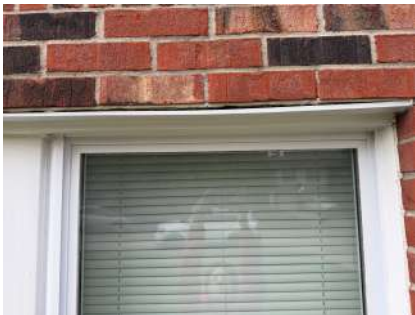
The trim above the first floor window was detached from the metal lintel. This allows water to enter and can corrode the lintel.

*First floor left side of house vinyl trim, pulling away from lintel*

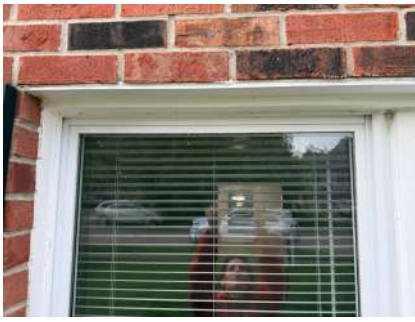
**✂ (3.2.1) Minor Defect:** The sealant, in several areas around the doors and window, has cracked or pulled away. It is important to keep sealant tight to keep air from entering/escaping from the home, and to keep water out.

*First floor left side needs to be sealed better*

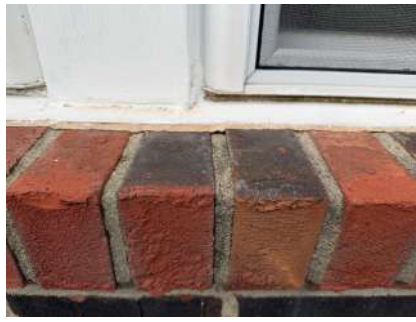
*Gaps and sealant around sale first floor left side*

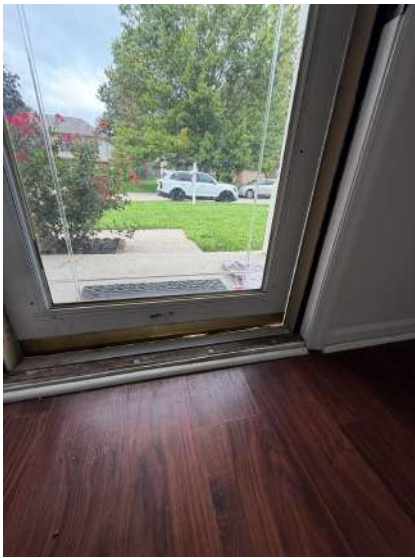
*Front storm door did not  
securely close weatherstripping  
on bottom was ragged*

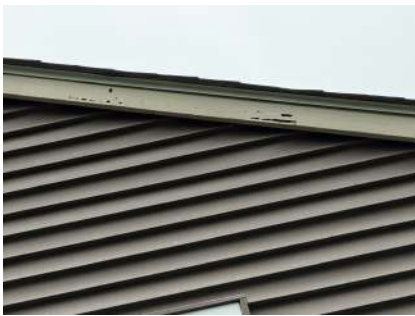
*Back of house*

**Defective:** The trim along the roofline at the back of the house was damaged. This could be caused by woodpeckers or wood destroying insects (or both).

I recommend having the trim replaced to prevent water from getting in or further damage.

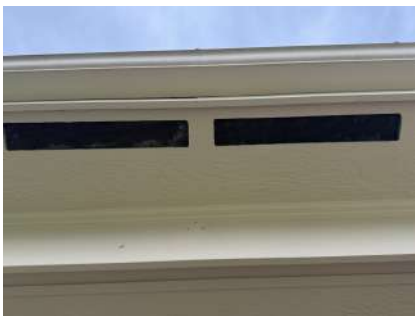
*Front porch soffits*

**(3.4.1) Minor Defect:** The soffits were somewhat dirty and looked like there was some paint spray on them.

I recommend having a contractor clean them to ensure that there is proper airflow in the attic.

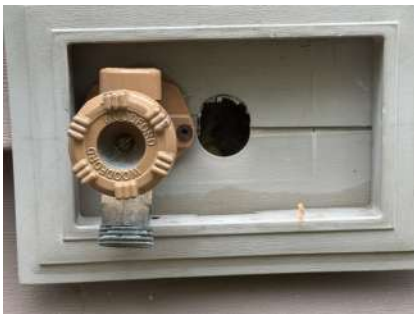
The back hose bibb leaked when turned on. The hole next to the bibb should be sealed. The front hose bibb was loose. I was unable to test the pressure because I couldn't remove the attached hose.

I recommend having a plumber evaluate and repair.

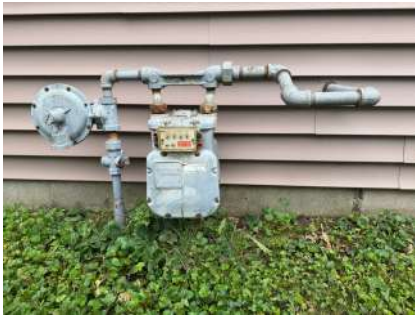
The pipe going into the house wasn't adequately sealed. I recommend having a contractor seal the penetration.

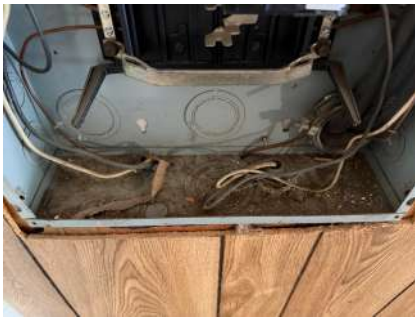
There was debris on the bottom of the panel. This is a fire hazard if there is ever a spark. This should be cleaned out.

The main panel is missing proper screws to secure the dead front cover. Install missing screws as needed for improved safety and please note that screws with sharp ends are not recommended.

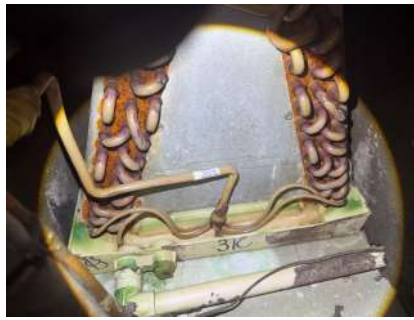
*Evaporator coil*

I observed heavy surface corrosion / rust on the evaporator coil and stagnant water in the primary condensate collection pan. This could imply a malfunctioning or partially restricted drainage system.

I recommend having a licensed HVAC contractor evaluate and repair.

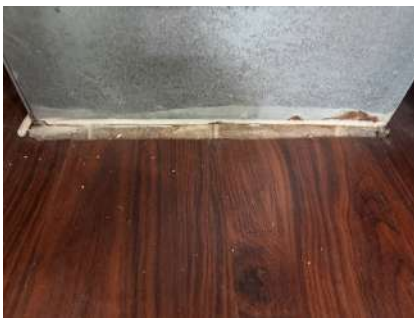
There was air leaking out of areas around the furnace. I recommend having an HVAC technician seal these.

*Need better seal*

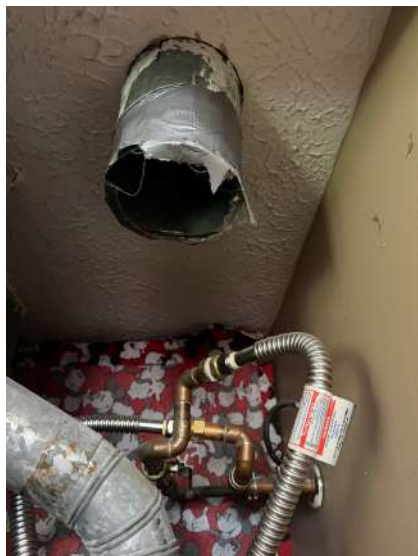
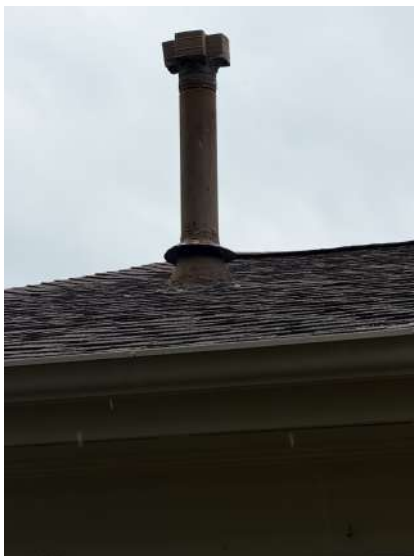
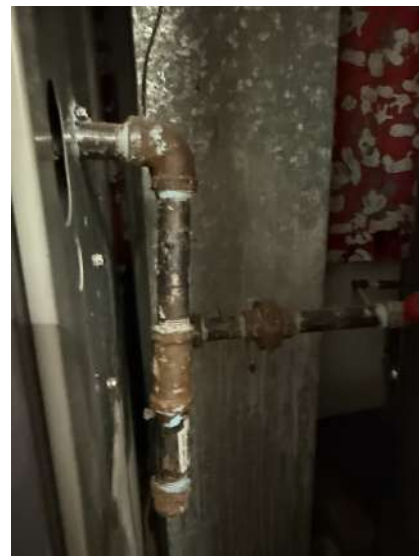
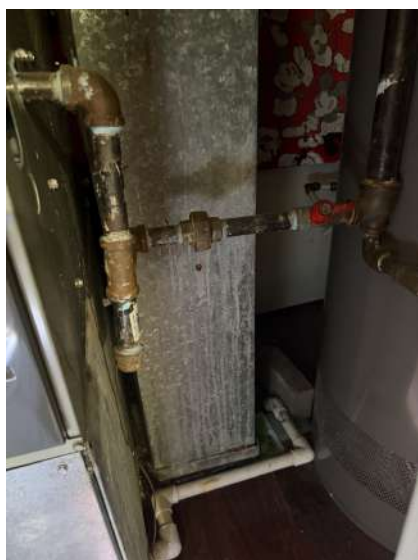
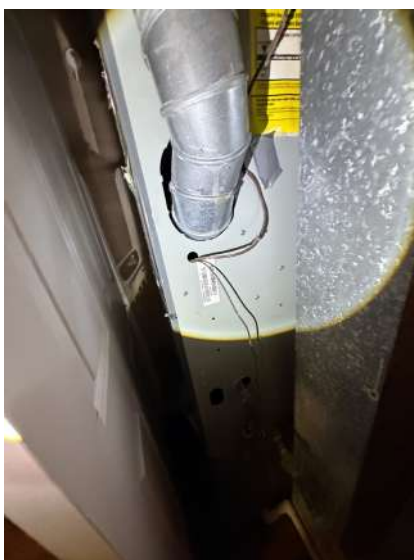
There were several issues that should be evaluated including corroded pipes and ducts not being properly sealed.

I recommend having a licensed HVAC professional evaluate

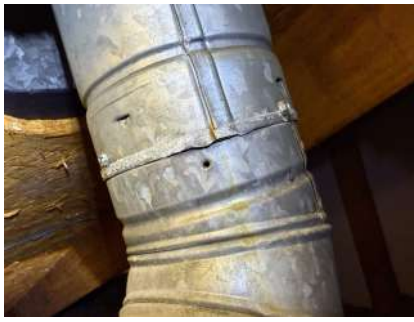
**Defective:** The ducts in the attic over the garage have holes due to corrosion. I recommend having an HVAC technician evaluate and replace.

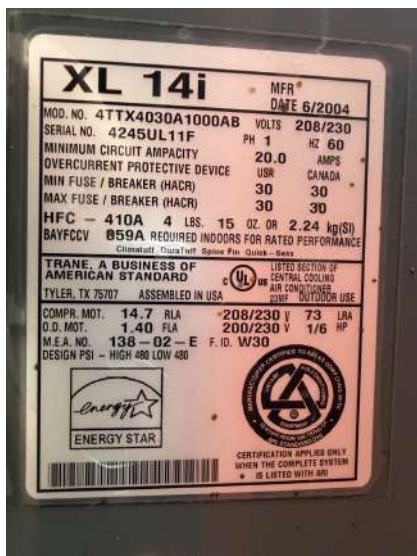
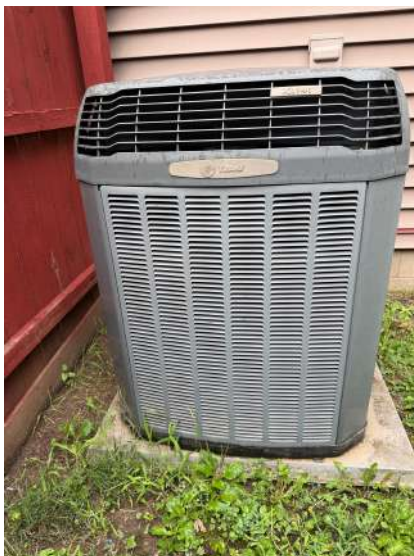
⚠️ **(8.5.1) Major Defect:** While the AC was still working, the condensing unit is close to the end of its life. Typically the service life for a condenser is between 15-20 years.

This, combined with the previous issue with the evaporator coils could indicate a new system will be needed relatively soon.

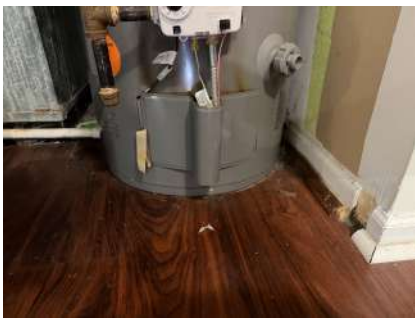
There was no drain pan underneath the water heater. A drain pan is recommended under water heaters that are located in finished spaces or where a leak could damage finishes. A pan without a drain is often of limited benefit/protection.

*No drain pan*

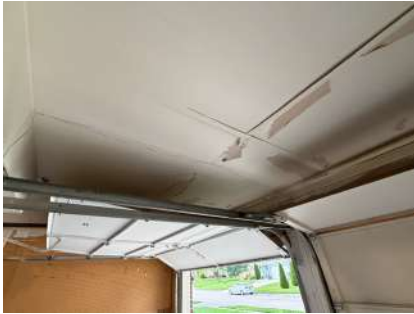
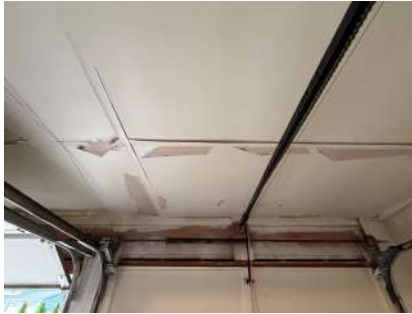
Damaged finishes were noted in the garage. The drywall on the ceiling is not properly secured and finished. The tape that seals the boards together had failed.

Repair garage finishes as needed.

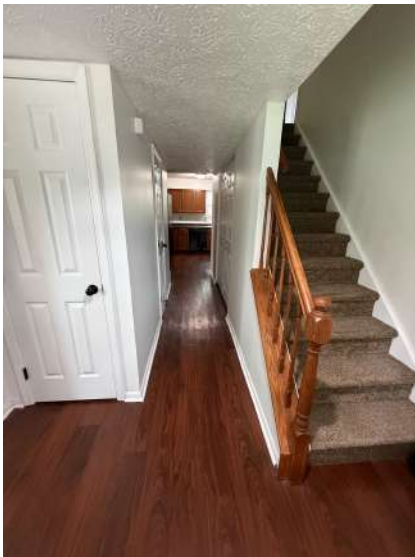
*7 foot ceiling in foyer and front hallway*

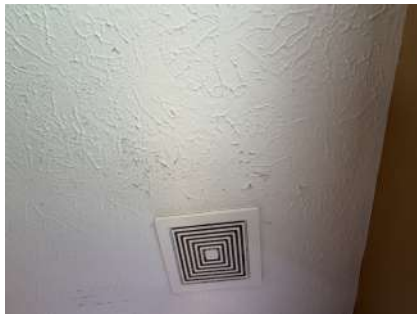
✂ (12.8.2) **Minor Defect:** The ceiling paint/compound was peeling around the fan in the master bathroom. This indicates that the fan may not be pulling air as it should.

*Ceiling is peeling around fan*

I recommend cleaning or replacing the fan.

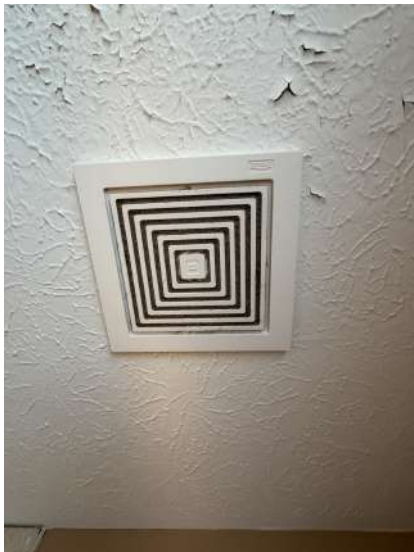
*drywall compound is peeling  
around that fan  
That fan is very dirty and not  
pulling Erin*

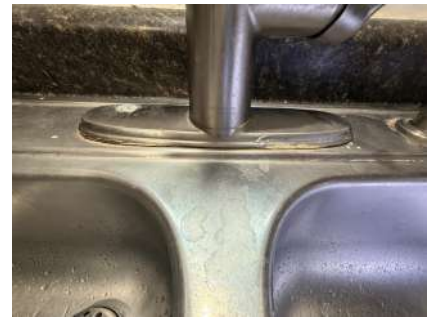
**Defective:** The sink surround was loose on the back. It should be secured.

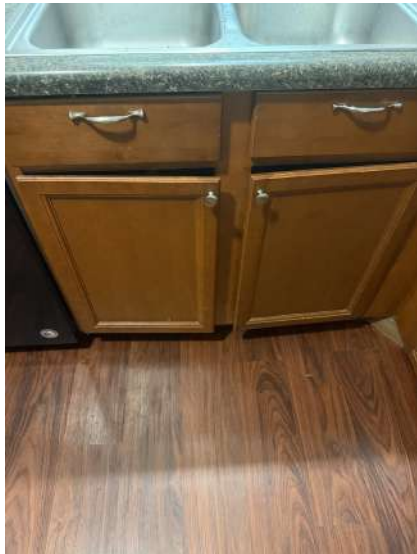
✦ **Additional information:** The cabinets underneath the sink do not close properly

*Cabinets underneath kitchen sink didn't close*

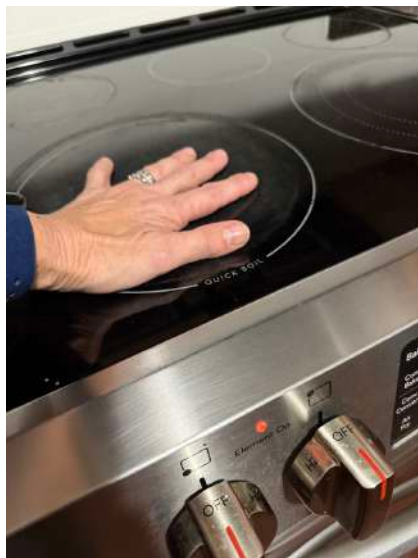
✦ **Additional information:** Long after the cooktop was off and cool, the "Surface Hot" indicator remained on.

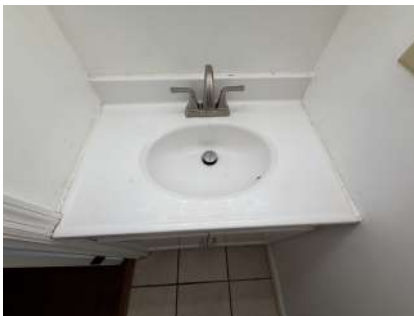
🔧 **(15.3.1) Minor Defect:** The faucet was loose. I recommend having a plumber tighten it so there won't be any future leaks.

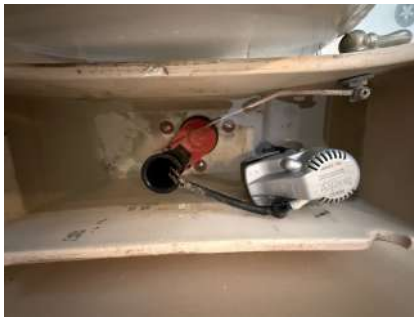
**Defective:** There are issues with the toilet. I recommend not using it until they are repaired, or the toilet is replaced.

- The toilet is not securely mounted onto the floor
- The toilet doesn't flush
- The seat is loose

*Toilet is loose and does not flush*

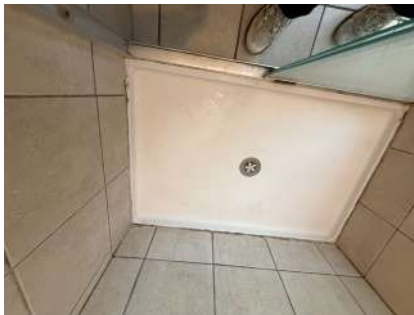
- Handle is loose
- Bacterial growth behind sealant
- Insufficient sealant in and around shower, including where the shower meets the floor.

*Bacterial growth behind caulk*

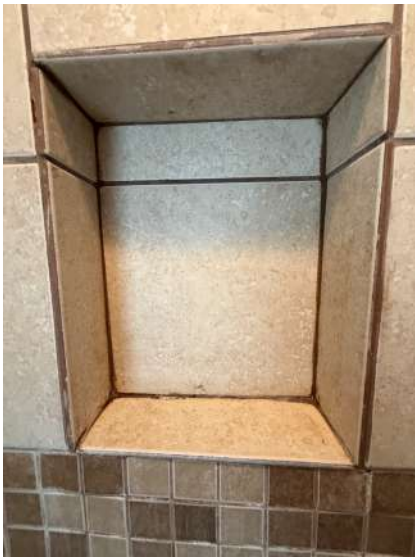
*Feel around metal piece  
connected wall  
Handle is loose*

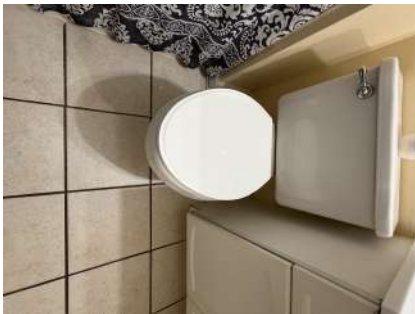
🔧 (17.3.1) **Minor Defect:** Toilet is loose and has a slow drain

*Hall bathroom toilet loose  
Slow drain*

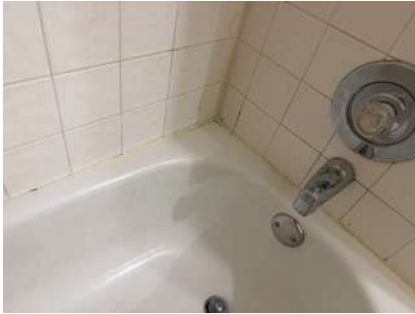
✂️ **(17.4.1) Minor Defect:** Areas around tub were not completely sealed, bacterial growth was observed.

*Bacterial growth behind caulk*

I recommend having the entire area recaulked.

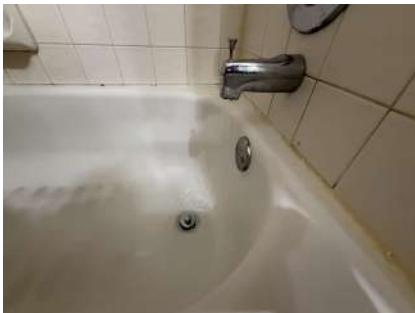
✂️ **(17.4.2) Minor Defect:** The bathtub faucet still runs when the shower diverter is up.

*Faucet still runs when shower is  
on*

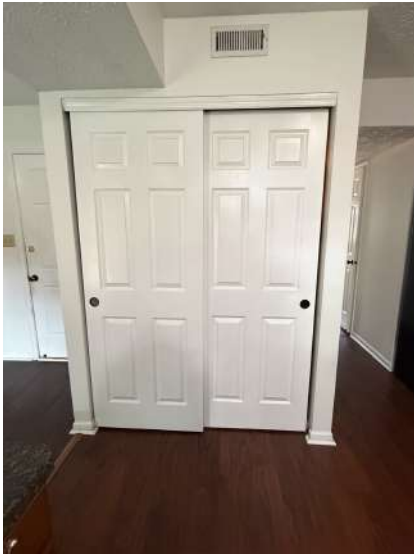
*Utility closet doors were not on bottom track leaving them to swing into utilities*

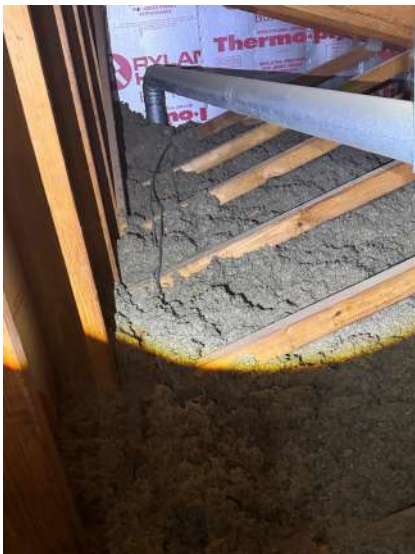
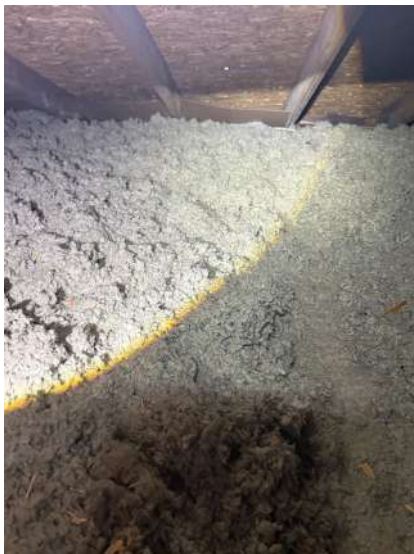
✂ (19.3.1) **Minor Defect:** There is wet insulation below the air duct penetration. I recommend replacing it to avoid any bacterial growth.
